Control of
Mine Tailing Discharges
- To Big River

a report prepared by

The Department of Natural Resources
January 1980

CONTROL OF MINE TAILING DISCHARGES INTO BIG RIVER

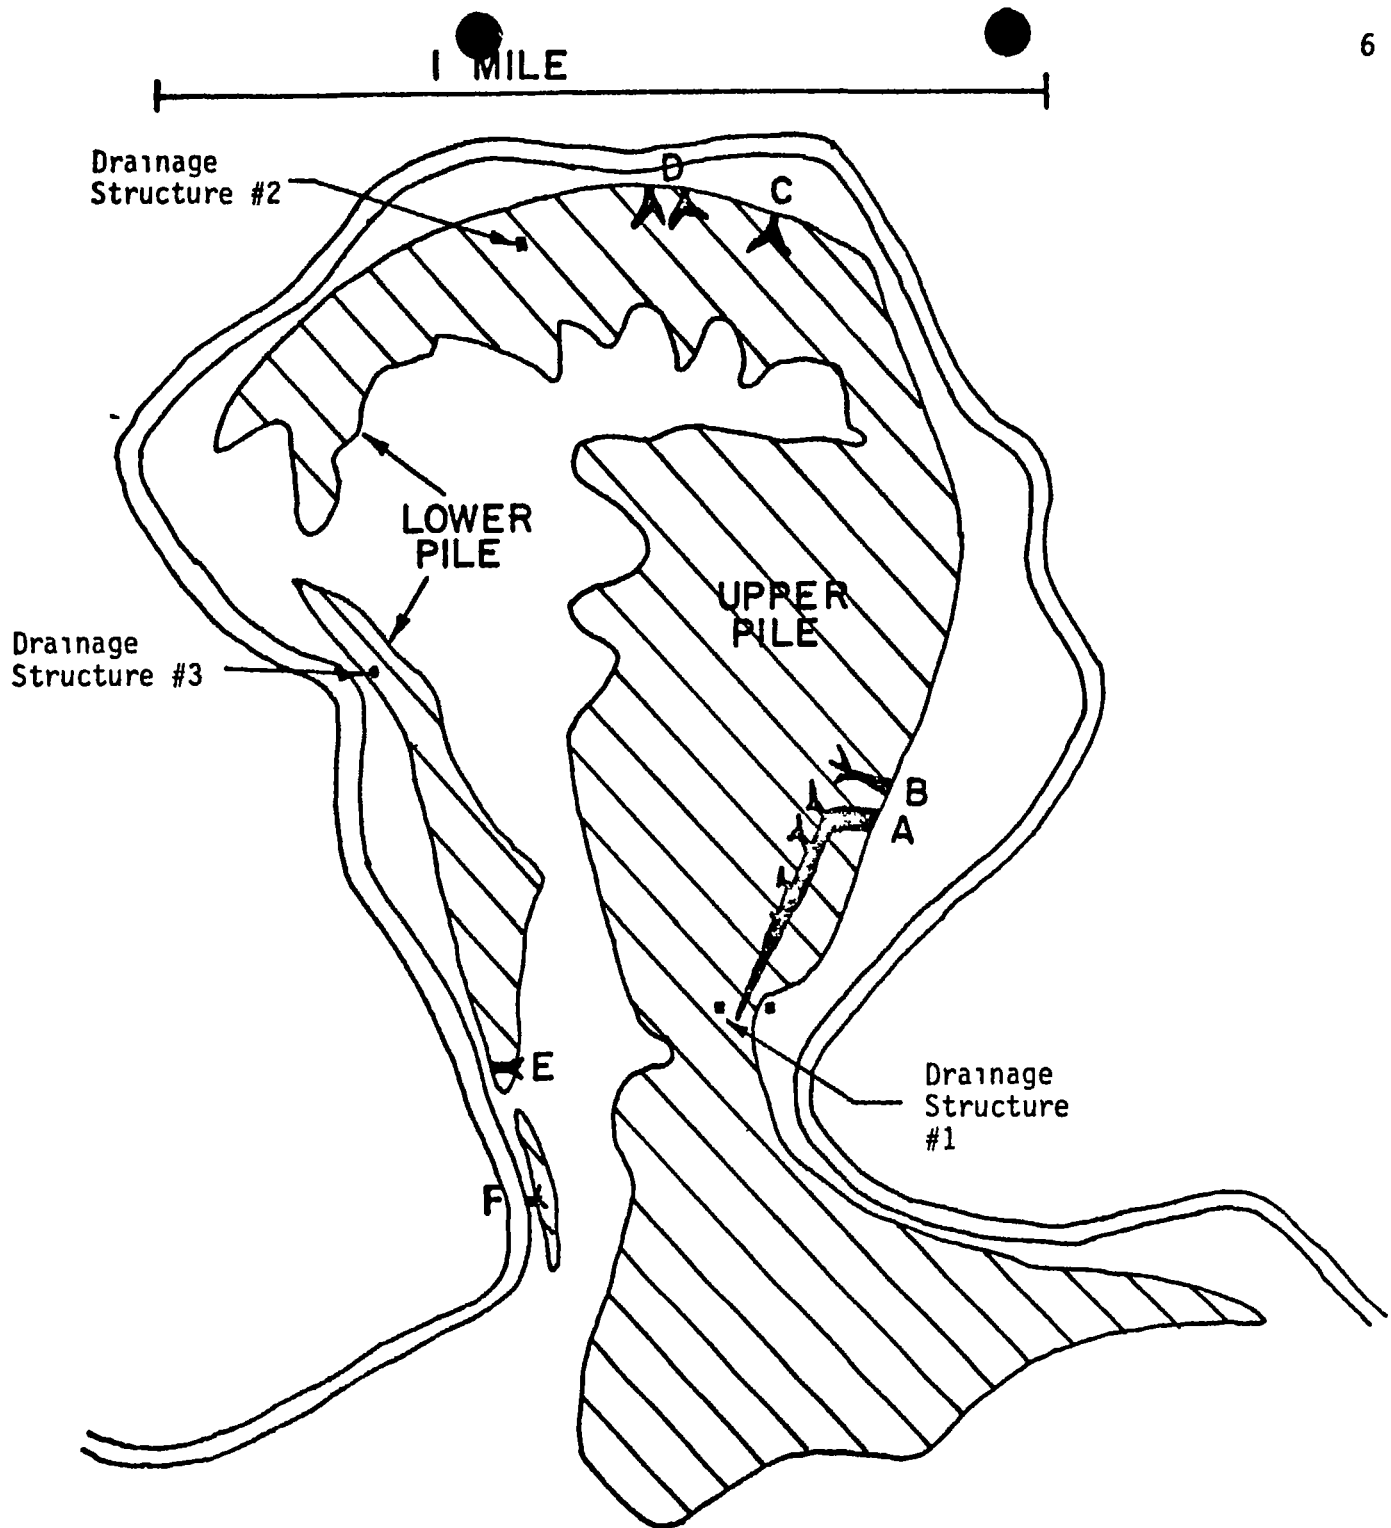
Fig 4 Plan View of Tailing Pile Showing Important Features

In addition to the items listed in alternative number I, repair other erosion sites as shown in Figure 4

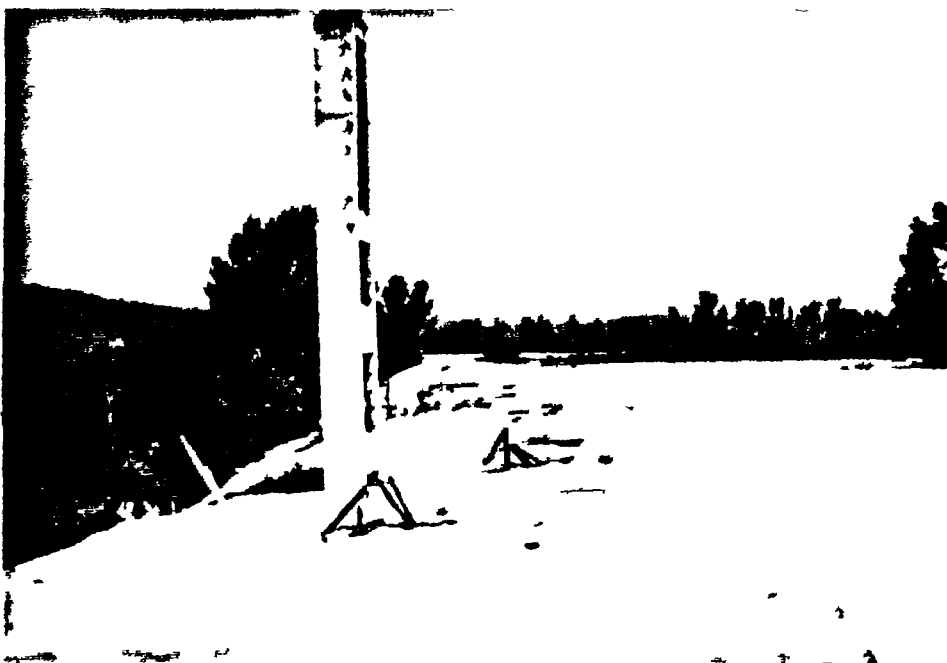
Fig 7 Drainage Structure No 3 This Structure is Located Outside the Ridge Line and Therefore Does Not Provide Any Drainage

shown in Figure 7 is at a point where the tailing pile runs to the edge of the Big River. Any overflow at this point will produce severe erosion and lead to large quantities of tailings entering the river.

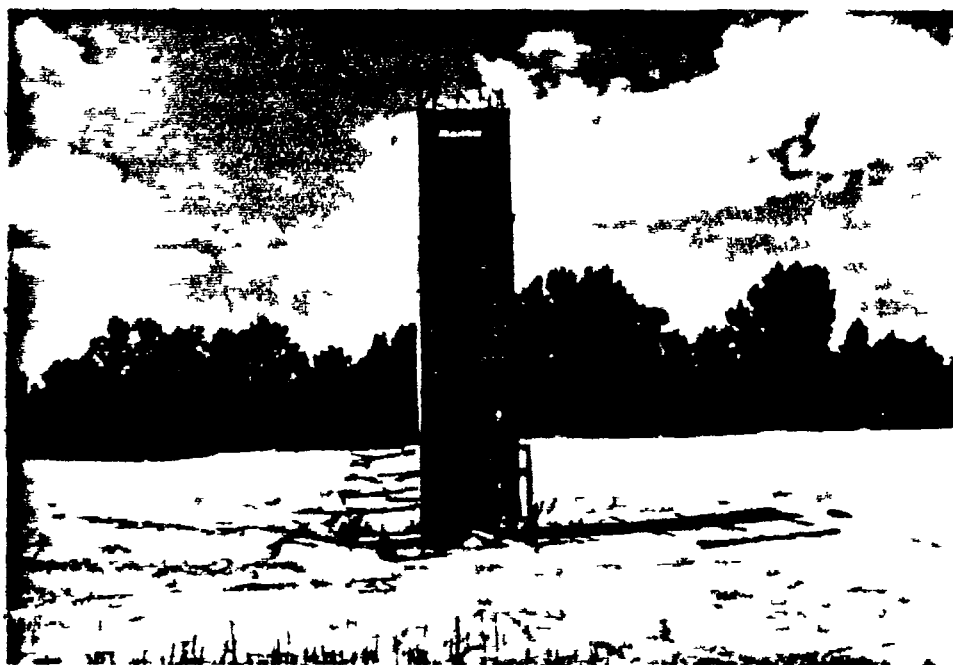
Fig 8 Drainage Structure No 2 This Structure Operates as an Overflow Outlet and Performs Effectively

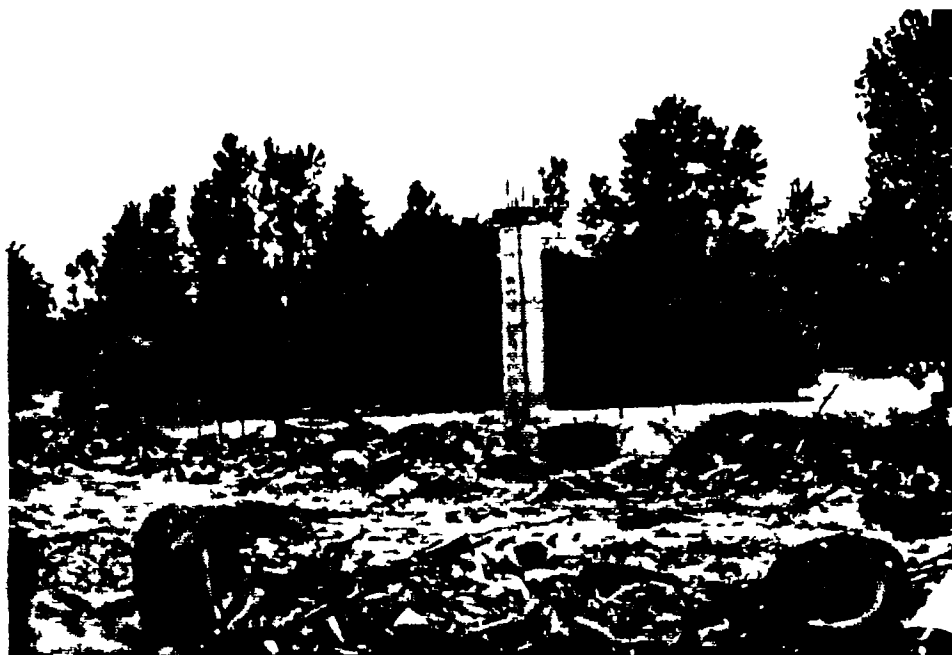
The outlet structure of most interest is that shown in Figures 4, 10, and 11. This structure is connected to another drain tower as shown in Figures 11 and 12. Apparently, this structure became blocked during a period of heavy rainfall and led to the massive erosion which occurred at Sites A and B. This structure is now functioning properly but is subject to plugging. Plugging may occur at the entrance to the structure but probably occurs in the secondary structure where the small pipe connects the two cells. During field investigations over the summer of 1979, the connecting pipe, shown in Figure 13, was found to be partially blocked with debris.

Fig 10 Drainage Structure No 1 This is the Drainage Structure That Became Plugged and Resulted in the Overflow and Erosion

The installation of additional drainage structures is not proposed. Of the three existing drainage structures, only structure No. 1 (Figure 10) requires modification. Drainage structure No. 1 is a double tower arrangement. Blockage appears to occur at the second tower at the center wall and small pipe. These should be removed as shown in Figure 32. In addition, some of the silt which has been deposited at the water inlet should be removed and the area altered to permit easier water access to the structure. It appears that when the 6 inch pipe becomes blocked in the second tower, silt deposits in the bottom of the water inlet structure and connecting pipe (Figure 32). Silt deposition in the connecting pipe can be reduced by removing the barrier wall and pipe and reducing the amount of debris that enters the structure.

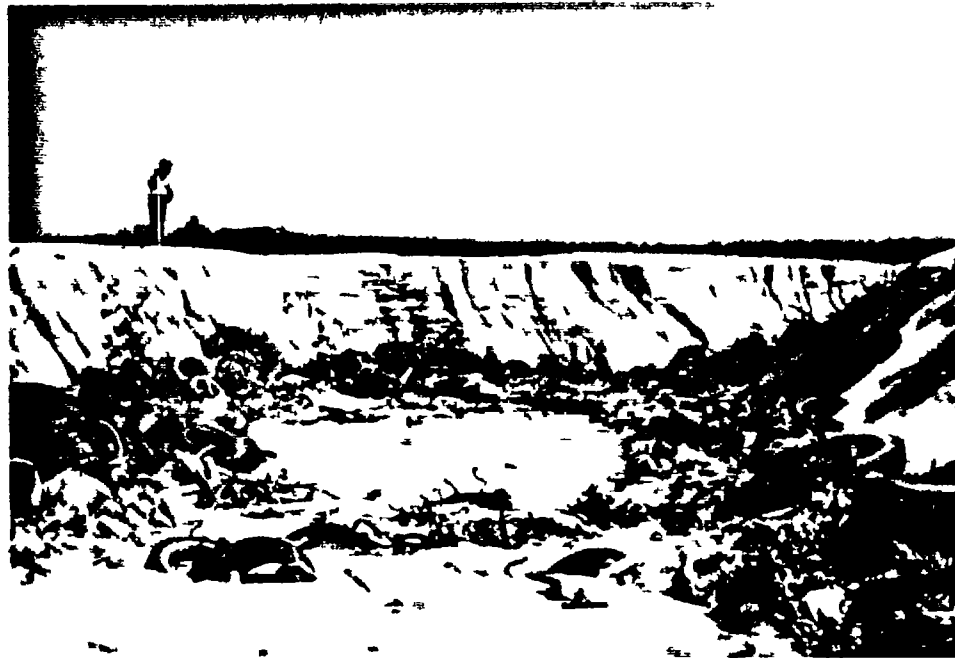
Fig 15 Tires and Other Debris Used In An Attempt to Control Erosion in the Large Gully

- a) Improve the existing berm near the major and minor erosion sites to reduce erosion, cease disposal of tires and other residue in the eroded ditch, and improve maintenance of the drainage structure

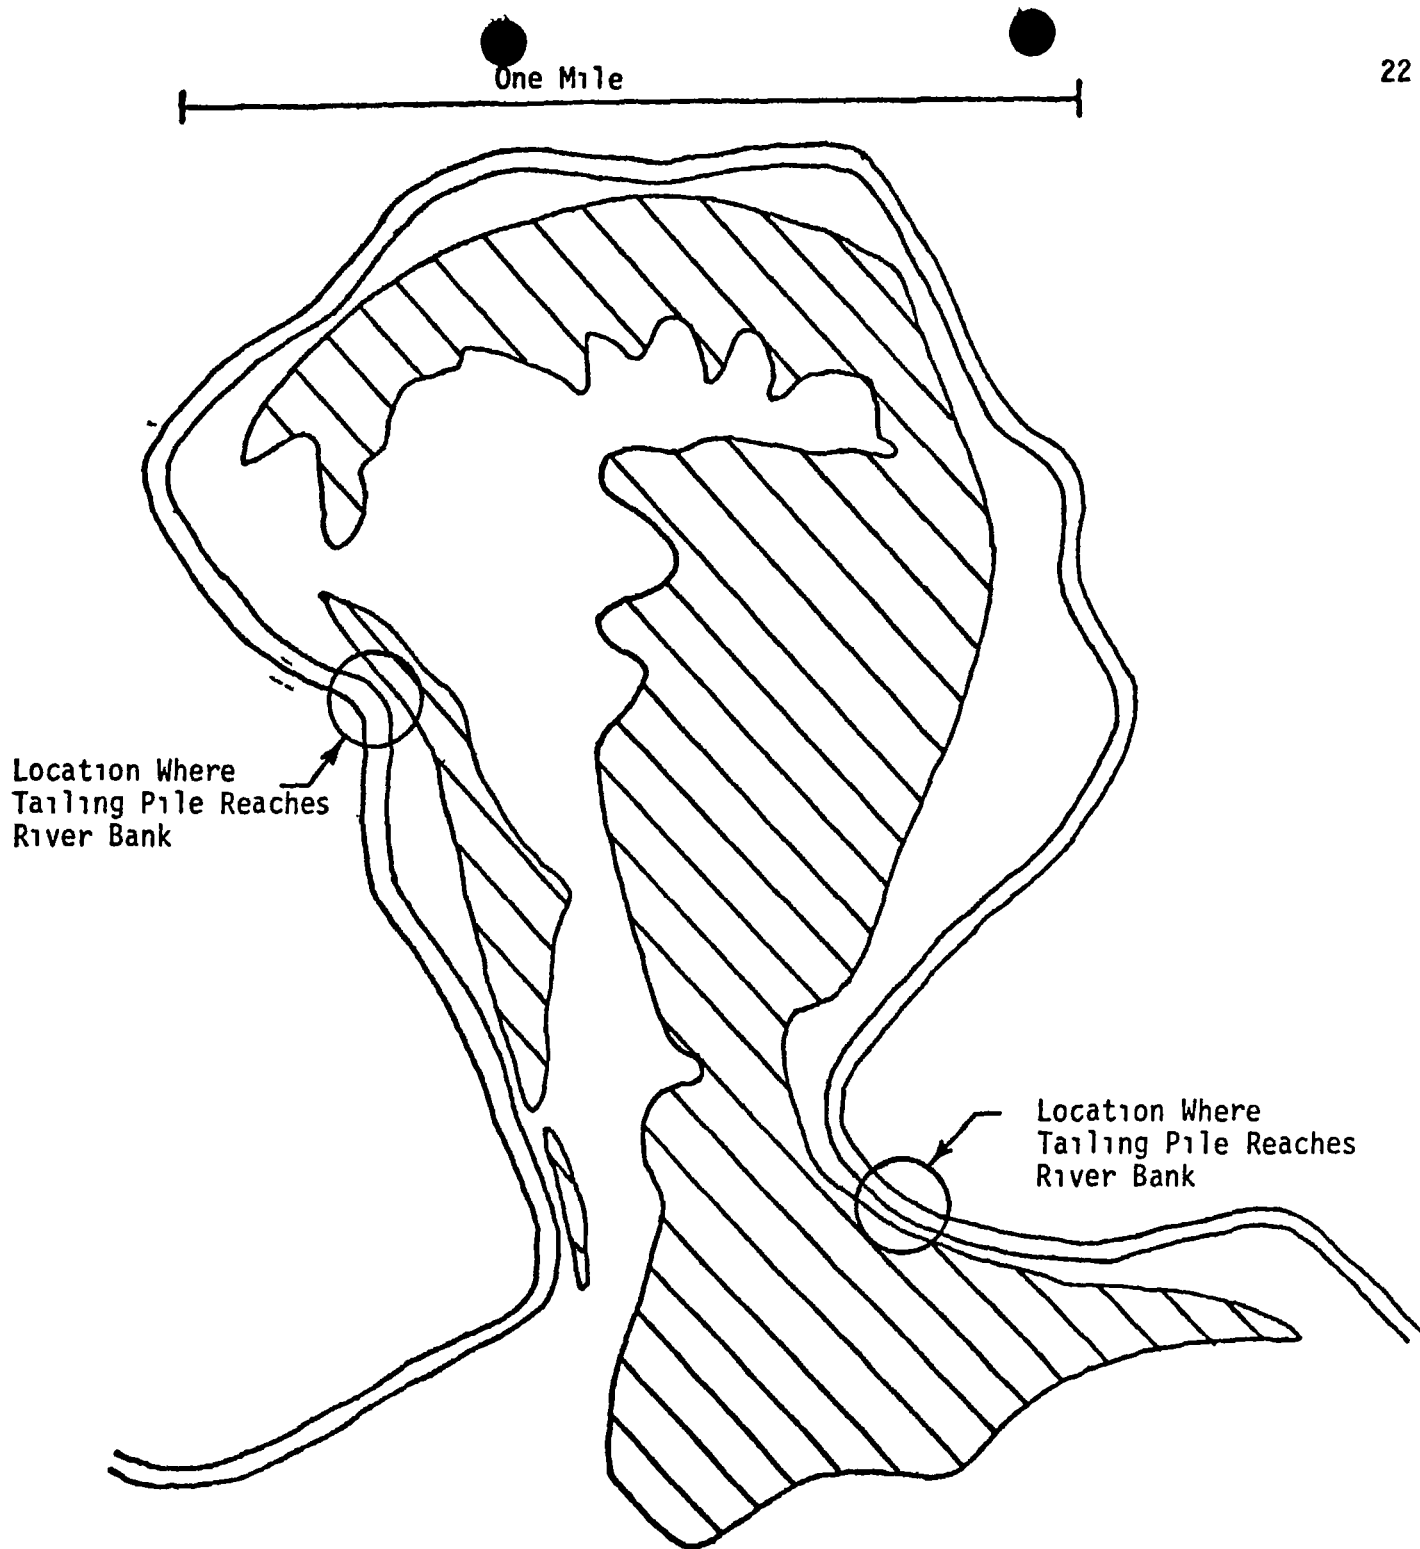
Fig 16 Location of Two Sites Where the Tailing Pile Reaches the River Bank

Several other erosion areas exist. Some of these sites contribute tailings to the river although the amounts are minor. Two sites exist, as shown in Figure 16, 22, and 23, where the tailing pile runs to the edge of the river and under high flow conditions can be directly eroded. Several other sites contribute tailings to the river. One of these, shown in Figure 17 and marked as Site G is located away from the major tailing deposits in an area owned by the St. Joseph Lead Co. Another is in a very small tailing deposit behind the area where fescue has been planted and is shown in Figures 17 and 24. Several other sites are shown in Figures 17, 25 and 26.

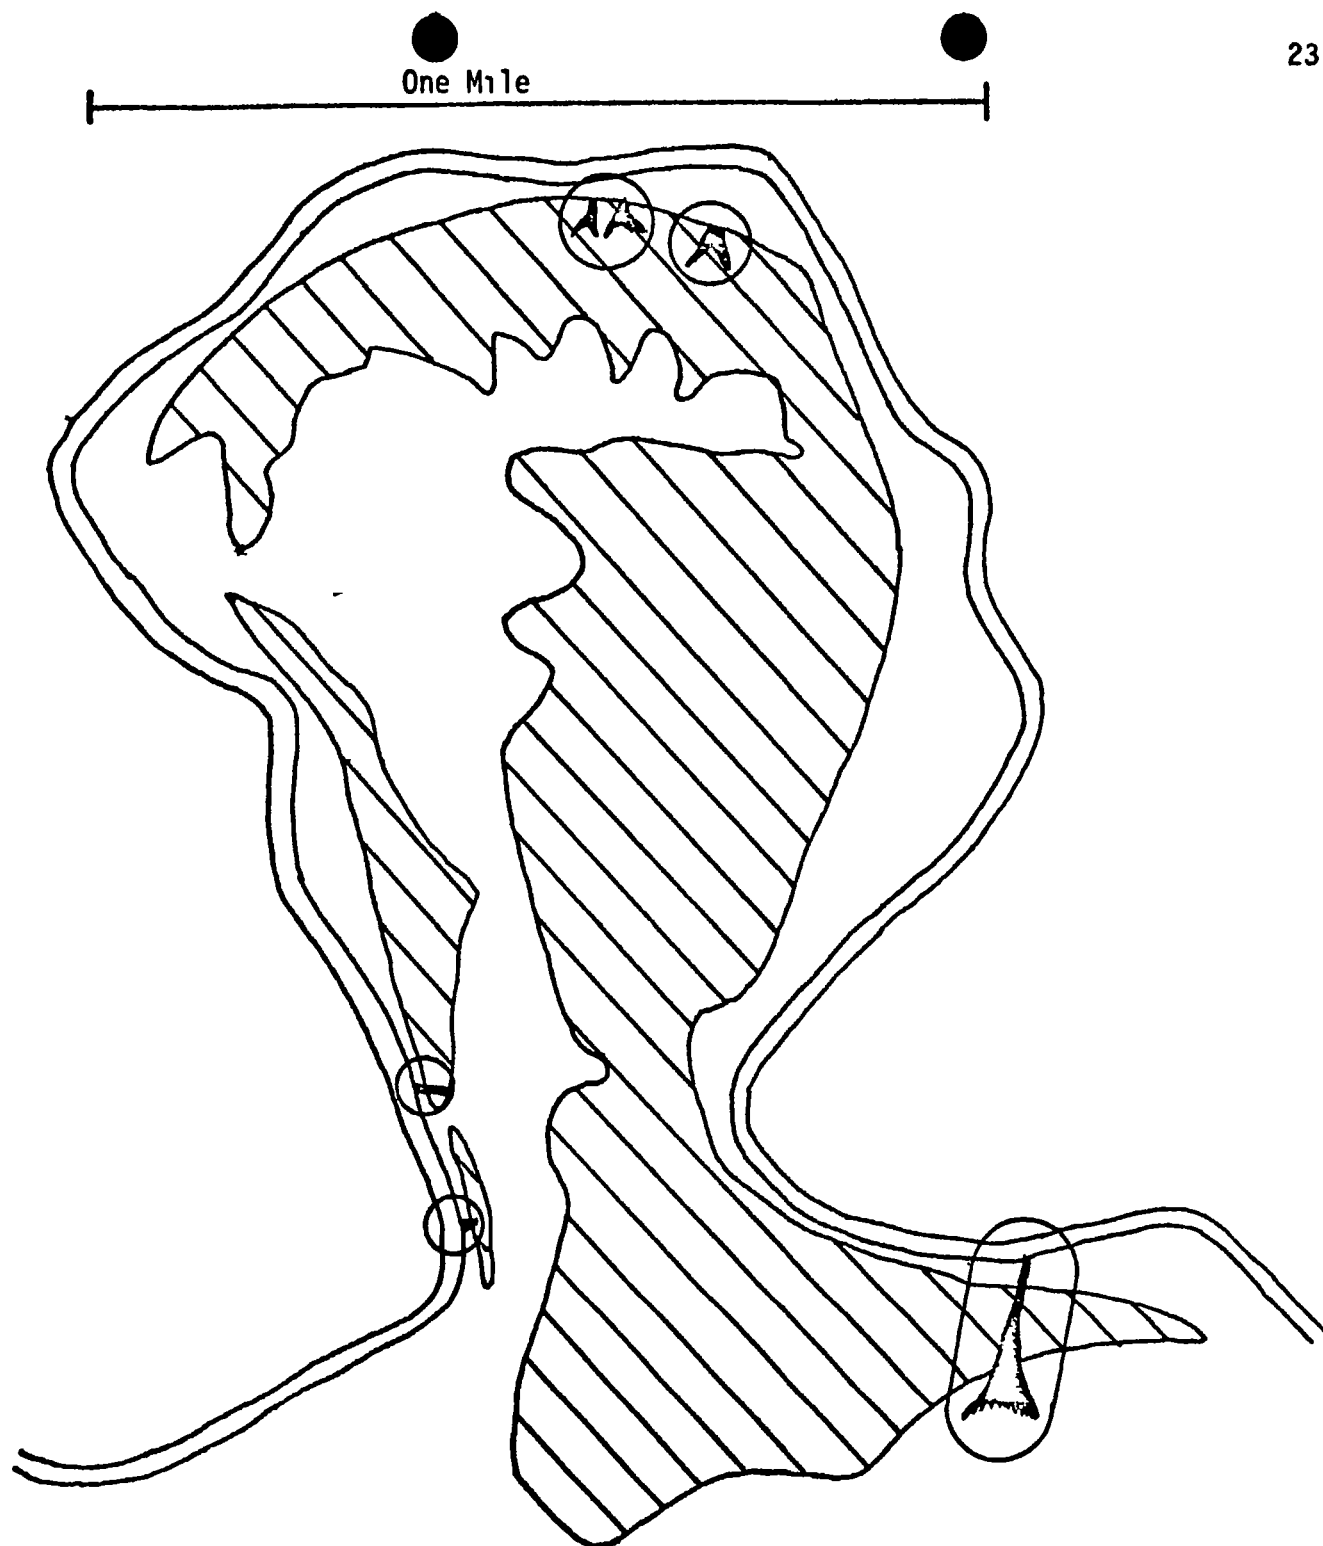
Fig 17 Minor Erosion Sites Which May Contribute Small Quantities of Tailings Into the River

All of these sites are considered minor. No repairs of these sites are recommended. Several of these sites were considered to be uncorrectable problems. Discharge from the site owned by St. Joe Mineral Corp. (Site G) probably can be minimized by constructing small holding basins to settle out tailings. The discharge marked as Site F on Figure 17 could be eliminated by rebuilding the rock wall on this site. The area marked Site E cannot be repaired. At Site E tailings were placed in an area through which an intermittent stream runs. The tailings from this site have been washed away and only minor erosion is now occurring. The sites marked as Sites C and D can be repaired by adding fill and reshaping the ground. These are the most likely spots for additional erosion control.

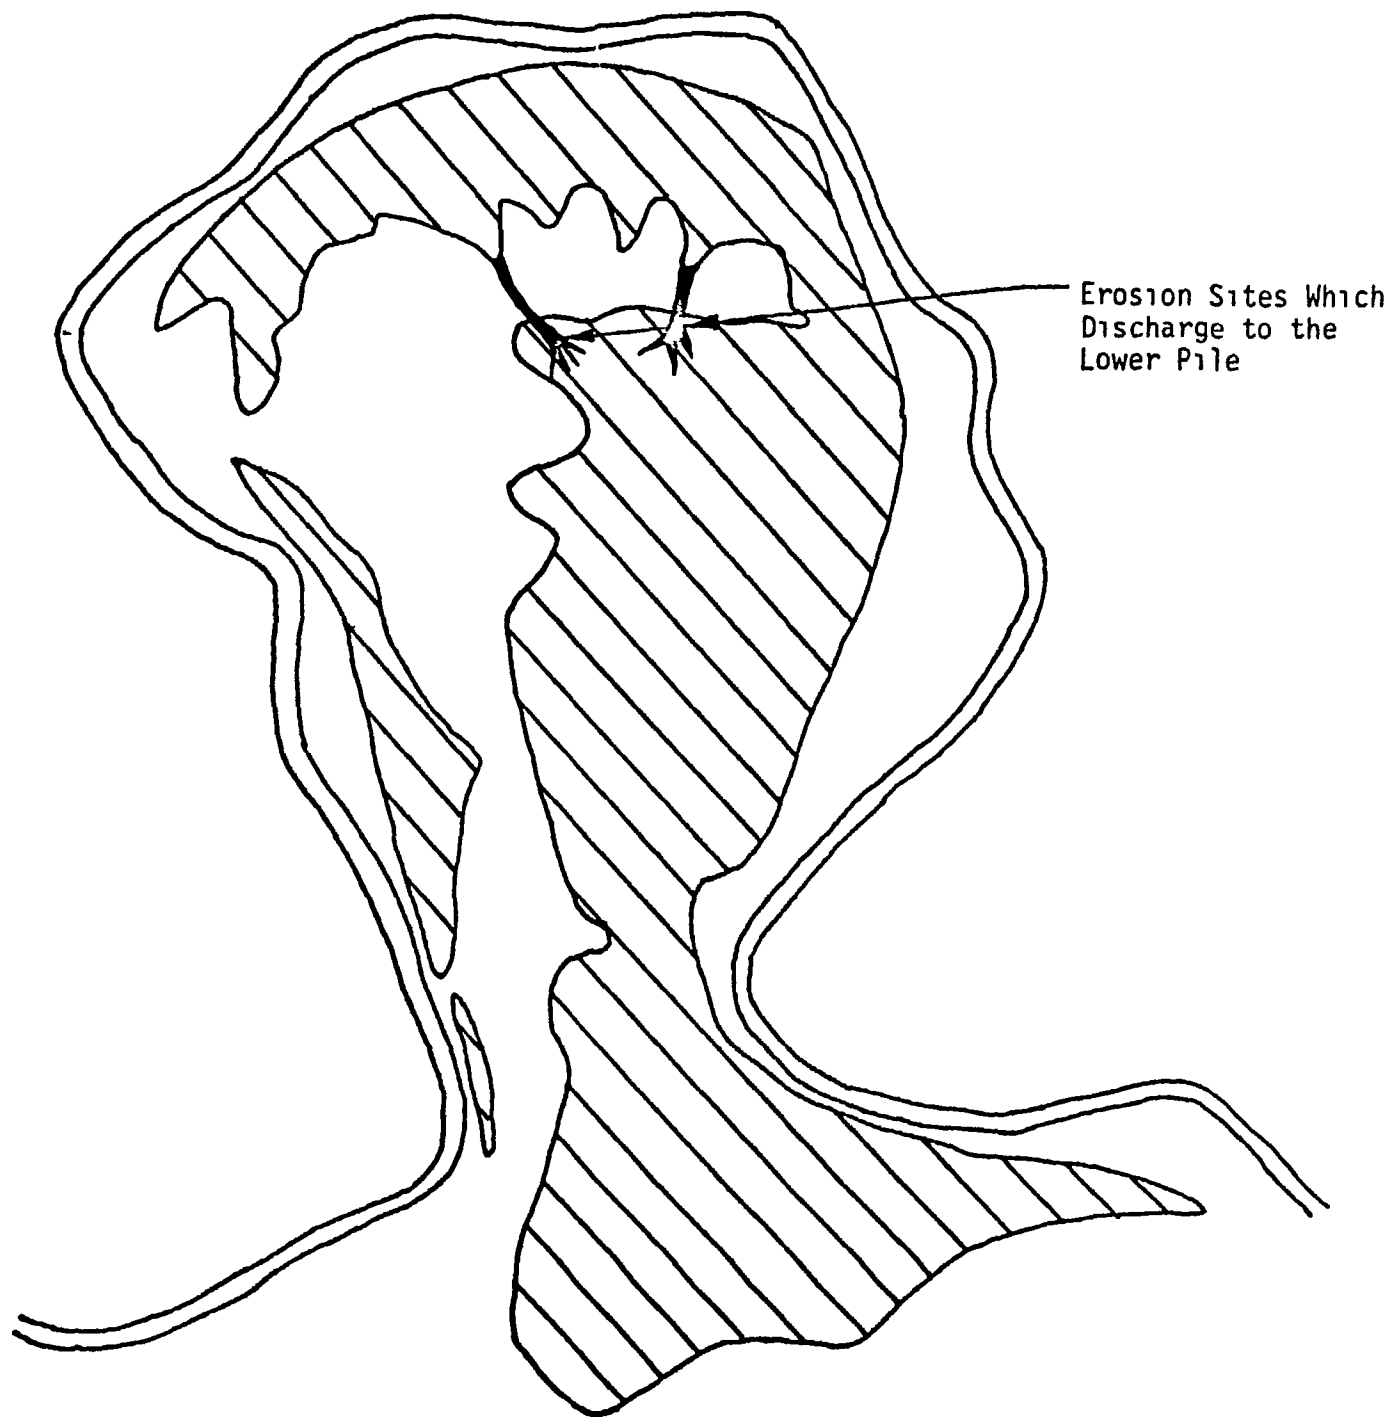
Fig 18 Erosion Sites on the Upper Pile These Sites Appear Serious But Contribute No Discharge to the River and Constitute no Potential Hazard

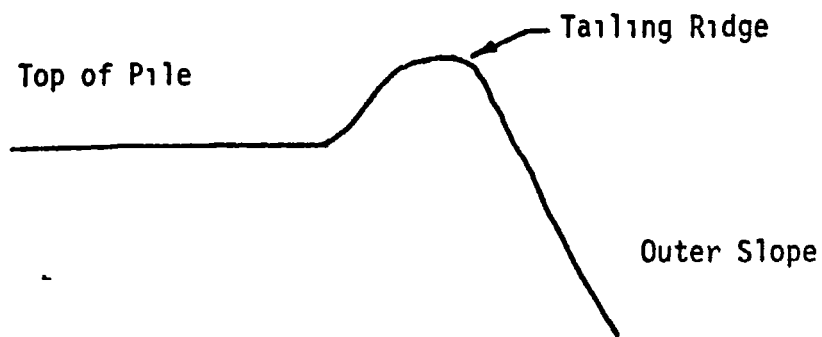
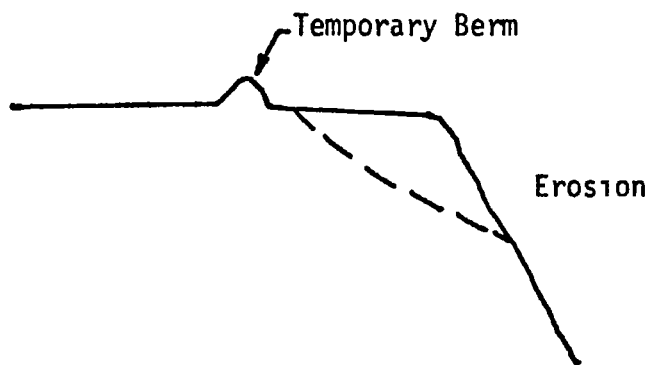
tailing pile is flat rather than crowned, erosion has occurred See Figure 20 A sketch of the existing and proposed ground profile at site B is shown in Figure 21 The first 3 recommendations all call for refilling these gulleys and reshaping the area

Water is Retained on the Top of the Pile and Cannot Run Off

Water Can Run Off the Outer Slope Resulting in Formation of Channels

Fig 20 Sketch Showing the Manner By Which Erosion Occurs

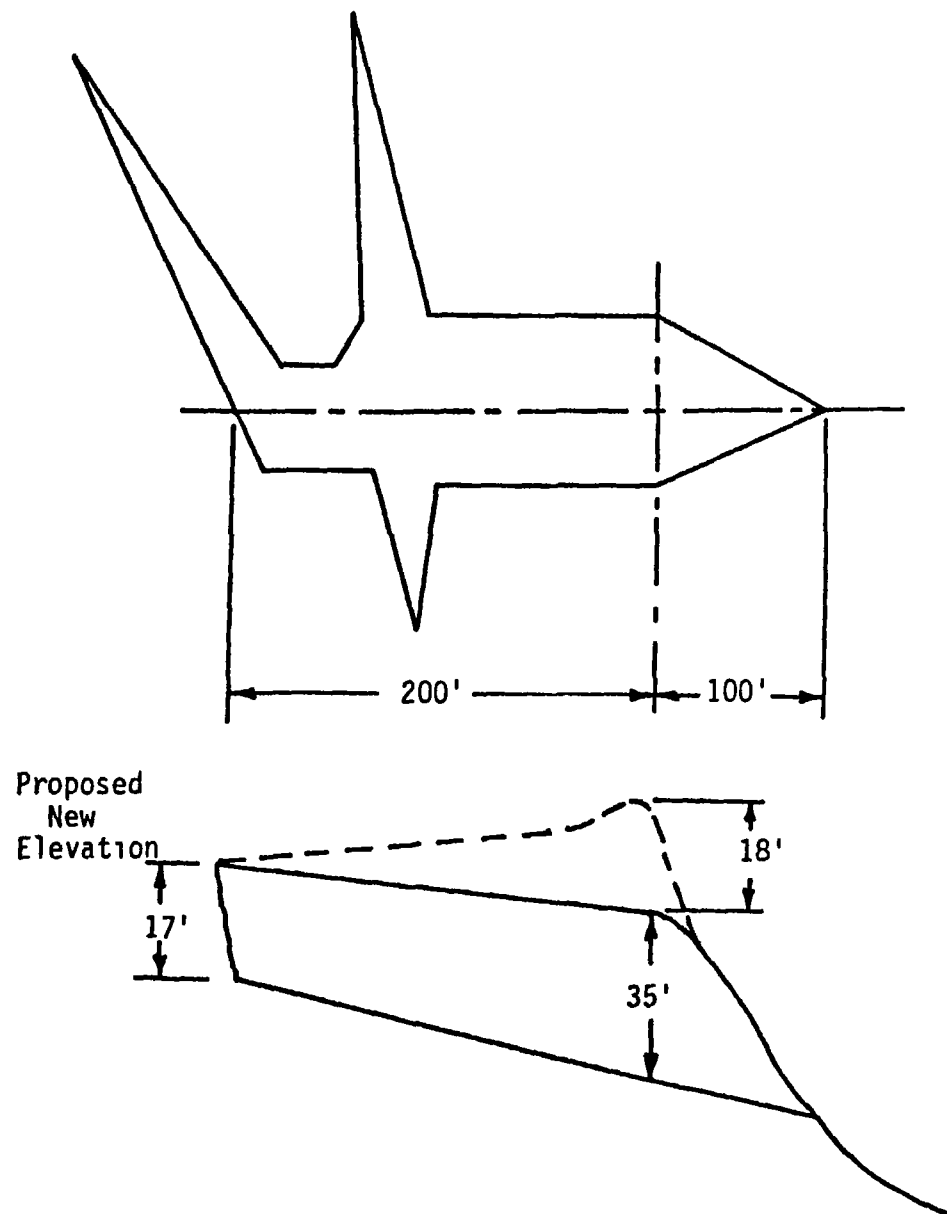
Fig 21 Plan and Profile of Erosion Site B and Proposed Fill Elevation

It is recommended that the 90,000 cubic yards from site A be entirely replaced. It is recommended that the ditches at site B be filled and that a surcharge of material of ten feet in depth be added to this area so that this location is raised to an elevation above that of the main portion of the pile. The corrections at site B will require approximately 40,000 cubic yards of material.

Deposition of approximately 40,000 cubic yards of tailings into the large gully and mechanically reducing the steep slopes should eliminate most of the erosion problem although the large ditch will remain and will be a potential source of problems if the drainage structure fails to perform
